Racor PF L2016 / 32007  
 Patent #6,086,763 / 6,554,139 B1 / 6,986,426, B2 / 6,983,851, B2  
 Wix 57314 Element  
 March 10, 2006  
 Test Performed by Bonavista Technologies, Inc  
 An Independent Laboratory

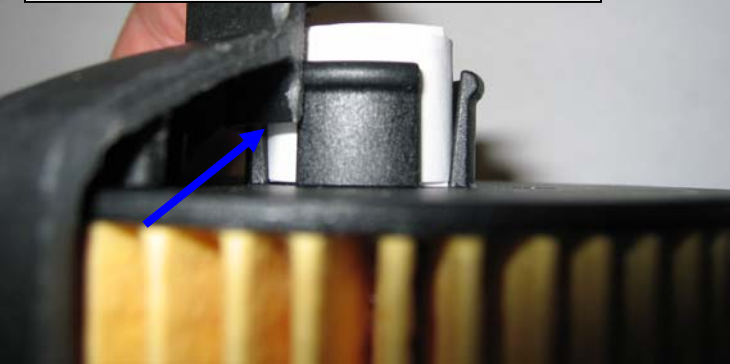
**Figure 1**

Racor end cap engineered to fit properly in screw cap to allow oil flow to bypass valve for engine protection

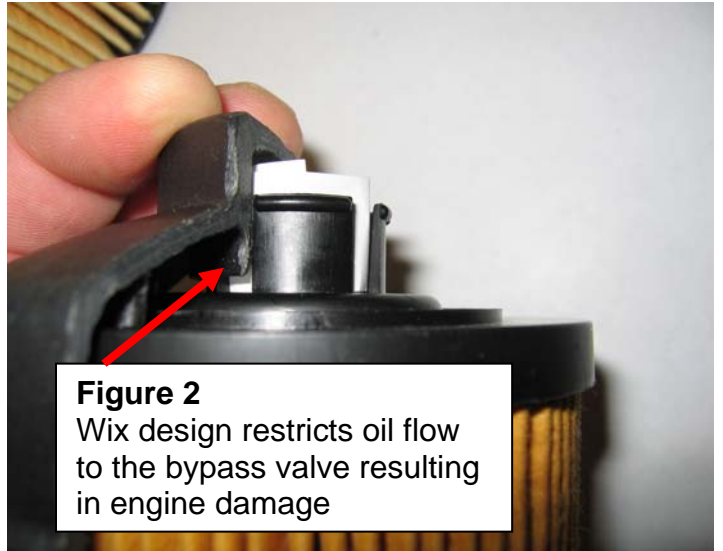
**Figure 2**

Wix design restricts oil flow to the bypass valve resulting in engine damage

2. The Wix element center tube design protrudes upward into the flow path of the oil to the bypass valve which will restrict or completely shut off the oil under cold starts or when the element becomes restricted during normal use. The result of the lack of lubrication under these circumstances will be component and or severe engine damage.

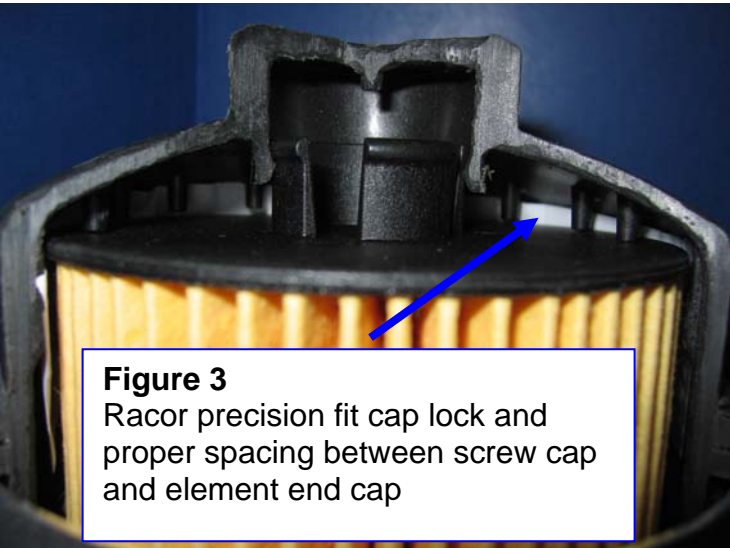
**Figure 3**

Racor precision fit cap lock and proper spacing between screw cap and element end cap

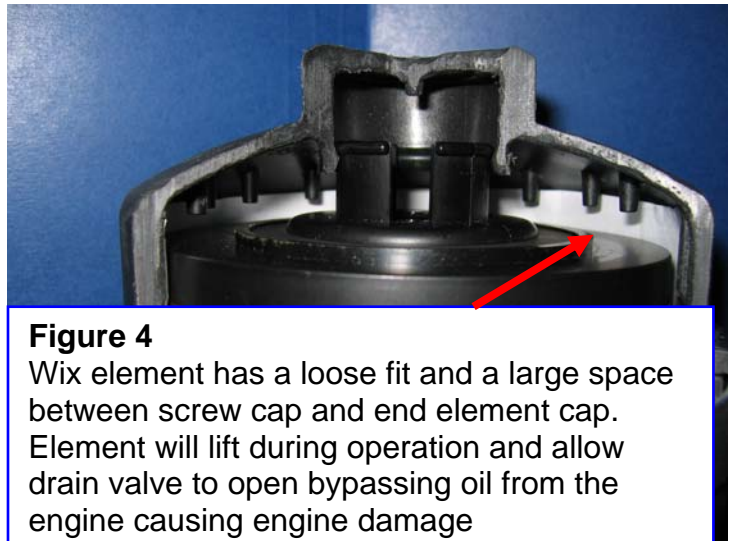
**Figure 4**

Wix element has a loose fit and a large space between screw cap and end element cap. Element will lift during operation and allow drain valve to open bypassing oil from the engine causing engine damage

3. Because of the poor fit of the Wix element in the screw cap the element will rise up during operation and possibly allow the auto drain valve to open and direct engine lube oil to the sump. This will result in loss of oil pressure to the engine causing severe engine damage.

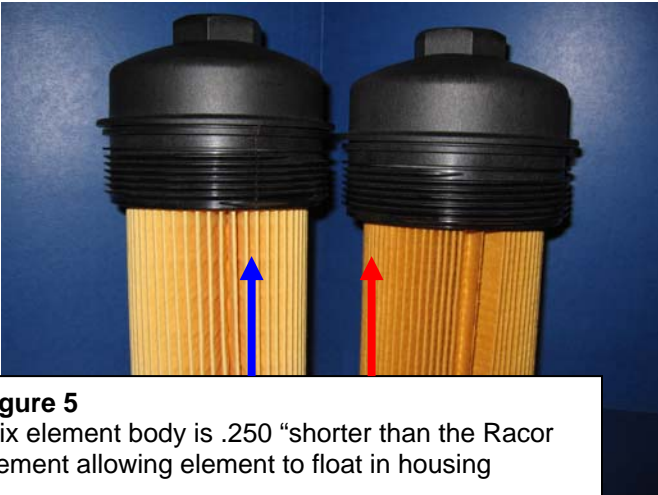
**Figure 5**  
Wix element body is .250 "shorter than the Racor element allowing element to float in housing

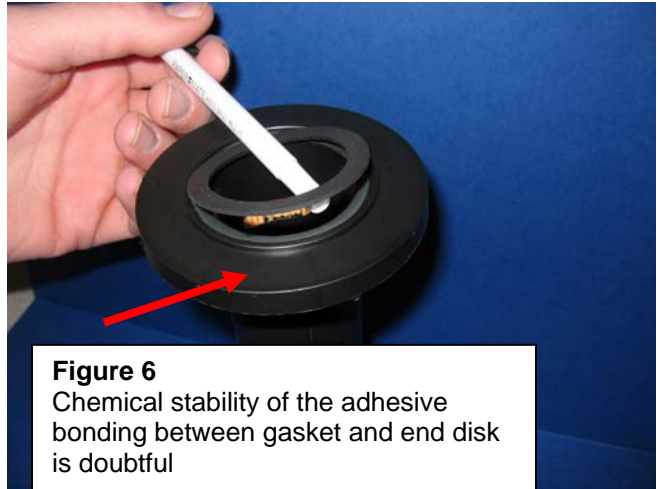
**Figure 6**  
Chemical stability of the adhesive bonding between gasket and end disk is doubtful

8. Less chemical stability of the gaskets.

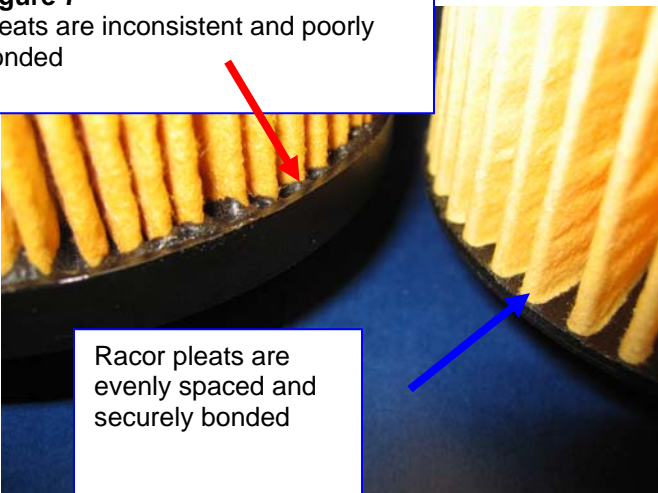
**Figure 7**  
Pleats are inconsistent and poorly bonded

Racor pleats are evenly spaced and securely bonded

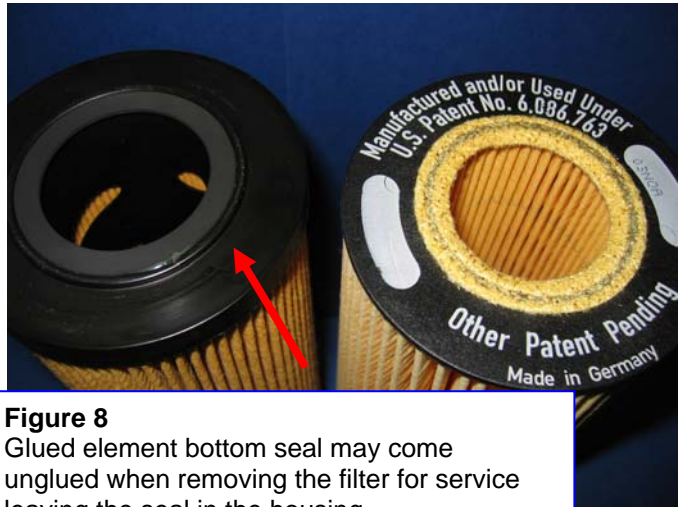
**Figure 8**  
Glued element bottom seal may come unglued when removing the filter for service leaving the seal in the housing

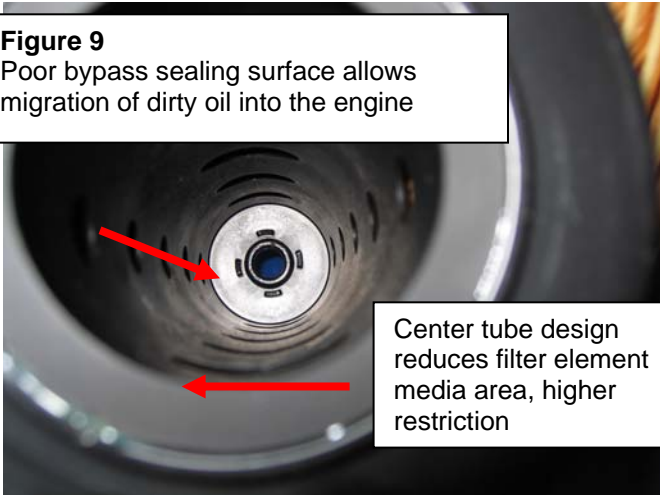
**Figure 9**

Poor bypass sealing surface allows migration of dirty oil into the engine

Center tube design reduces filter element media area, higher restriction

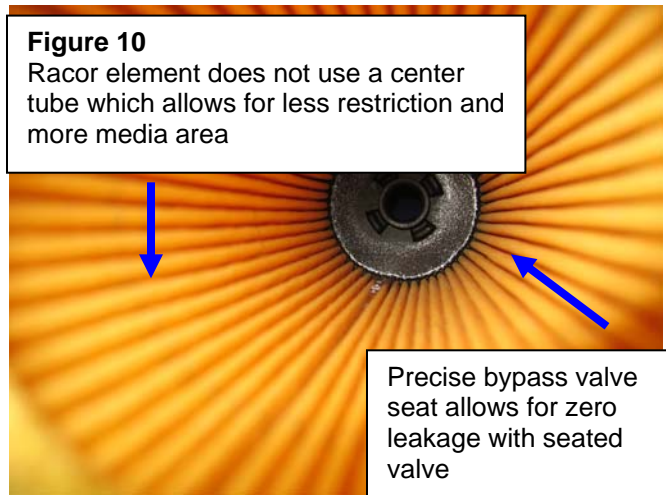
**Figure 10**

Racor element does not use a center tube which allows for less restriction and more media area

Precise bypass valve seat allows for zero leakage with seated valve
