Racor PF L2016 / 32007
 Patent #6,086,763 / 6,554,139 B1 / 6,986,426, B2 / 6,983,851, B2
 Wix 57314 Element
 March 10, 2006
 Test Performed by Bonavista Technologies, Inc
 An Independent Laboratory

Critical Features

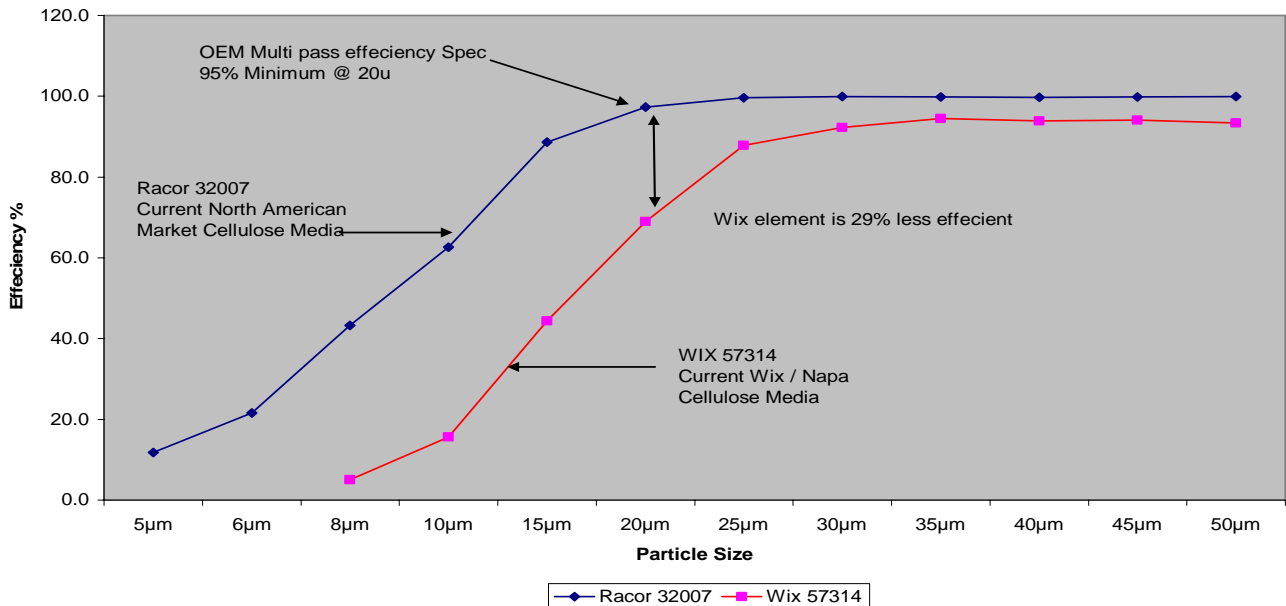
Element	Over all Height	Element Height	Pleat Count	Pleat Length	Pleat Height	Total Area Sq.”	Media area Difference %	Efficiency @ 10 micron	Efficiency @ 20 micron	Element Restriction
Racor	6.875	6.5	52	6.375	0.687	497	10% more	63.20%	97.80%	1.3 psid Avg. Diff.
Wix	6.875	6.25	68	6.125	0.5	446		15.60%	69%	5.2 psid 75% Higher

PERFORMANCE
 ITEC Specification: 95% @ 20 Micron
 Racor Efficiency: 97.4% @ 20 Micron
 Wix Efficiency 69% @ 20 Micron

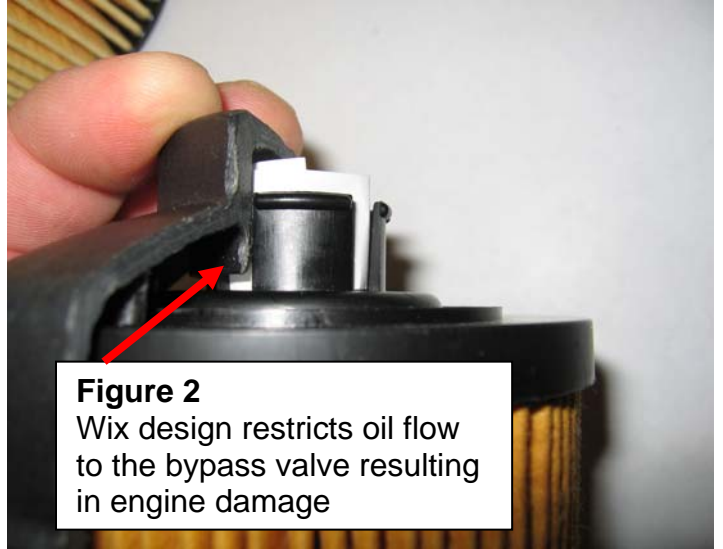
Figure 2

Wix design restricts oil flow to the bypass valve resulting in engine damage

2. The Wix element center tube design protrudes upward into the flow path of the oil to the bypass valve which will restrict or completely shut off the oil under cold starts or when the element becomes restricted during normal use. The result of the lack of lubrication under these circumstances will be component and or severe engine damage.

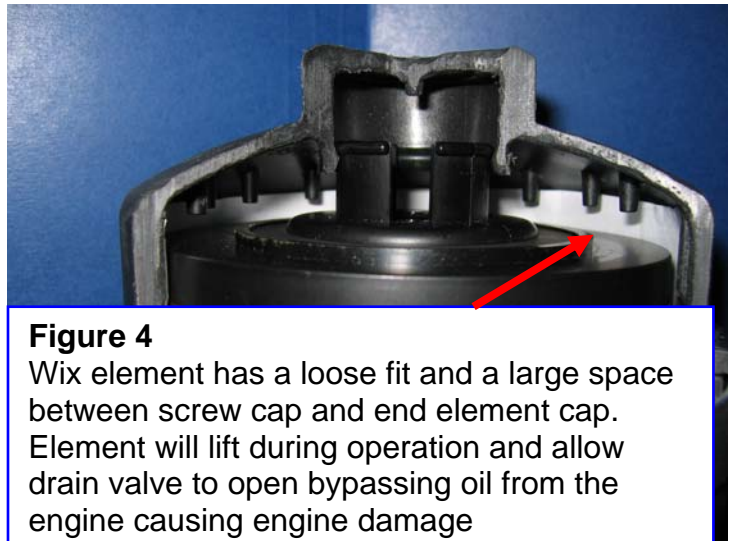
Figure 4

Wix element has a loose fit and a large space between screw cap and end element cap. Element will lift during operation and allow drain valve to open bypassing oil from the engine causing engine damage

3. Because of the poor fit of the Wix element in the screw cap the element will rise up during operation and possibly allow the auto drain valve to open and direct engine lube oil to the sump. This will result in loss of oil pressure to the engine causing severe engine damage.

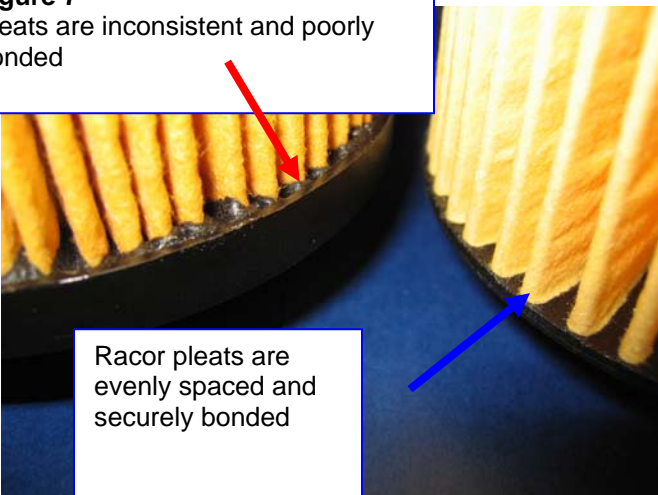
Figure 7
Pleats are inconsistent and poorly bonded

Racor pleats are evenly spaced and securely bonded

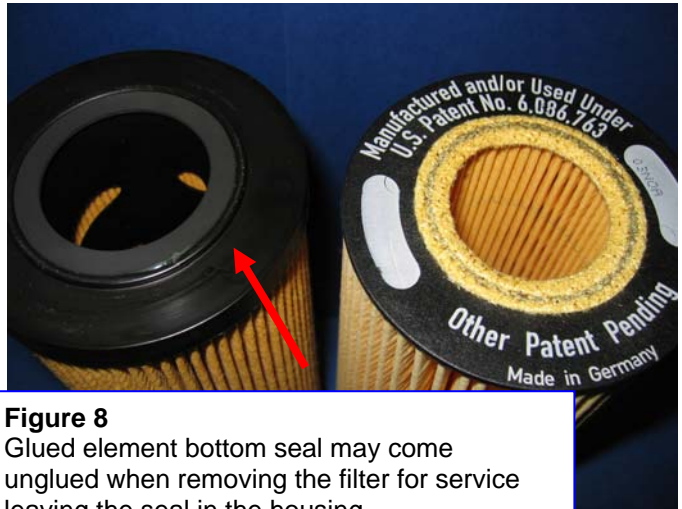
Figure 8
Glued element bottom seal may come unglued when removing the filter for service leaving the seal in the housing

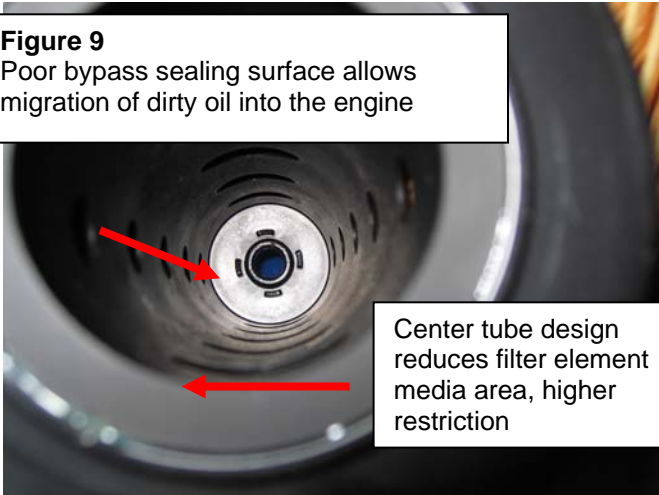
Figure 9

Poor bypass sealing surface allows migration of dirty oil into the engine

Center tube design reduces filter element media area, higher restriction
